Friends of Francis Field

To: Chairperson Trayon White, Sr., and the Committee on Recreation, Libraries,
and Youth Affairs
Date: April 5, 2022
Re: Testimony for Oversight Hearing, regarding Department of Parks and Recreation
FY 2023 Budget and Mayor's request for \$3 million for Francis Field Renovation

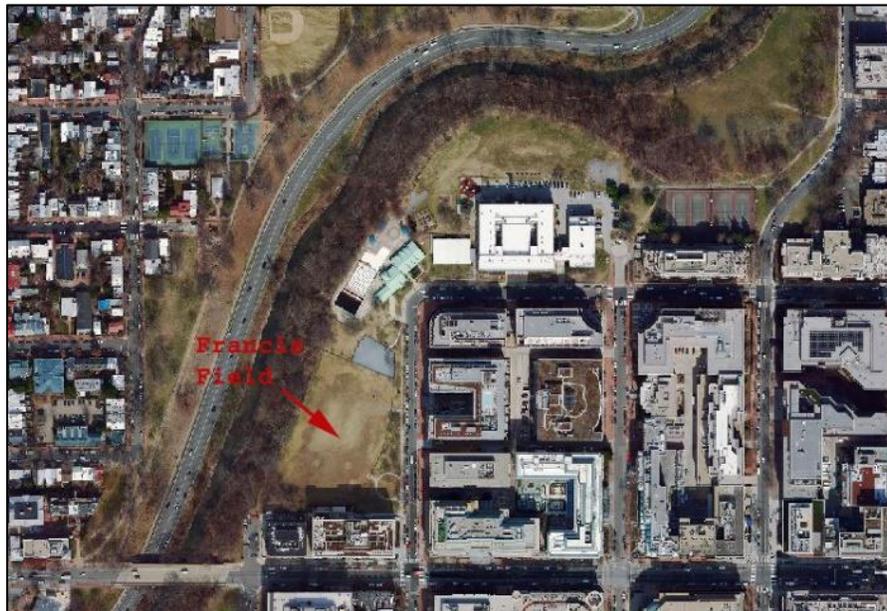
Figure 02. Francis Field indicated in 2021 aerial photo from DC GIS Atlas Plus.

The natural-turf field is not well tended, and the species change color with the season. The aerial photo in Figure 02 above is the most recent. It appears to have been taken in winter. Most photos of the field in any season show it with large areas of bare dirt in the playing field area. Year to

year photographs show that it has existed in bad condition and need of maintenance. The field has had no irrigation system for the last 28 years.

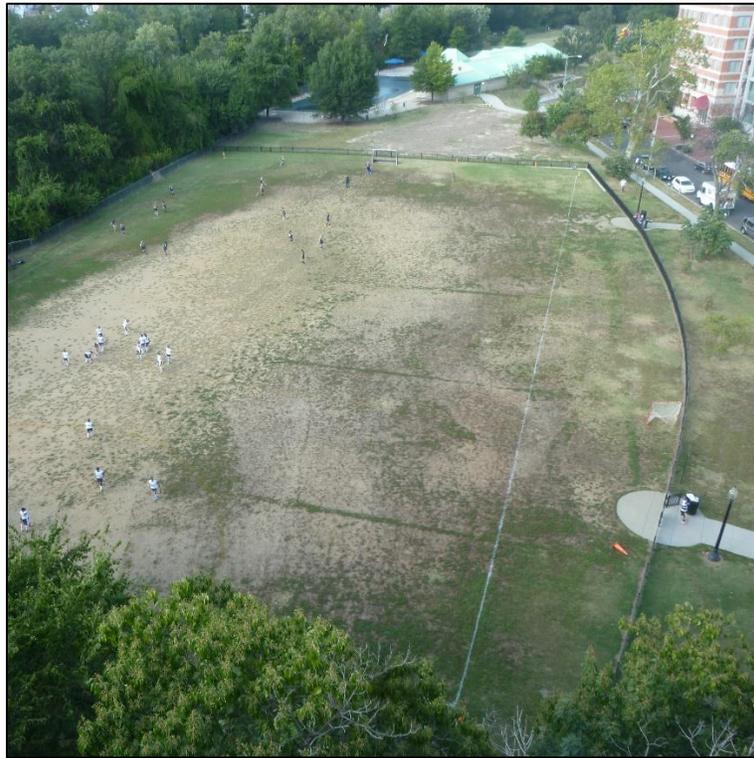
Figure 03. School Without Walls, Field Hockey on Francis Field, 19 Sep 2013.

The location of a non-functioning irrigation system under the field is shown by the green vegetation lines in Figure 03 above, as the old pipes appear to trap water at certain places.

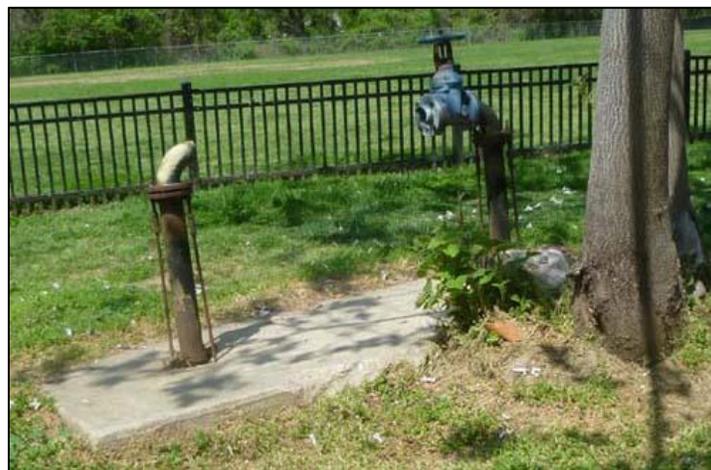
The system under the field is no longer connected to a water source. The old control valve has been vandalized and abandoned, but it still creates an obstacle and hazard in the passive park area to the east of the playing field. It is shown below in Figure 04.

Figure 04. Obsolete 1991 Irrigation Valve.

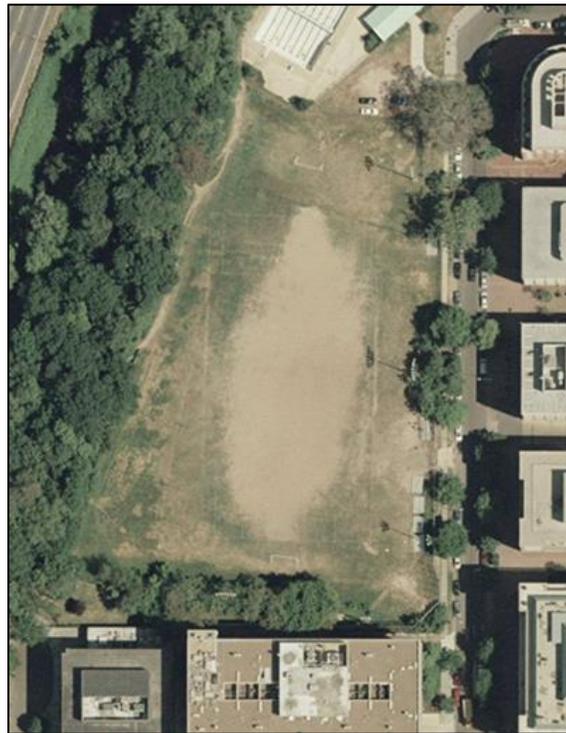
But it was abandoned two years later and the irrigation was not maintained. The playing field surface turned to dust in the summer and mud in wet weather. The aerial photo in Figure 06 below shows the condition about ten years later:

Figure 06. Francis Field condition in 2002 aerial photo.

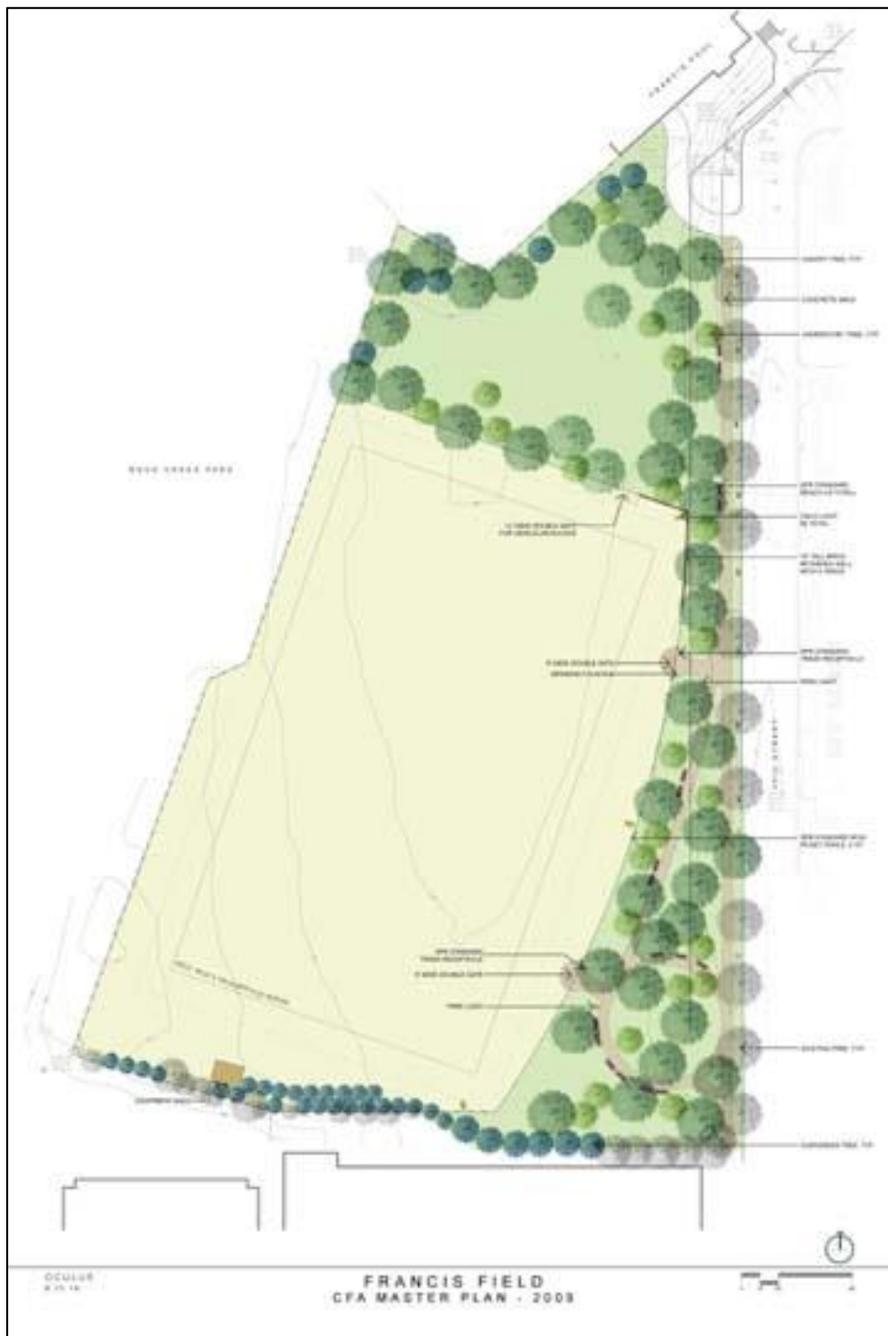
That was done on paper, at least, in a landscape plan ordered by the Zoning Commission, developed by DPR with community and stakeholder input, and reviewed by the U.S. Commission of Fine Arts. The review was required by federal law, as the field is partially owned by the National Park Service, and is part of Rock Creek Park and Parkway.

Figure 09. Master Landscape Plan submitted by DPR and approved by Commission of Fine Arts, 2009.

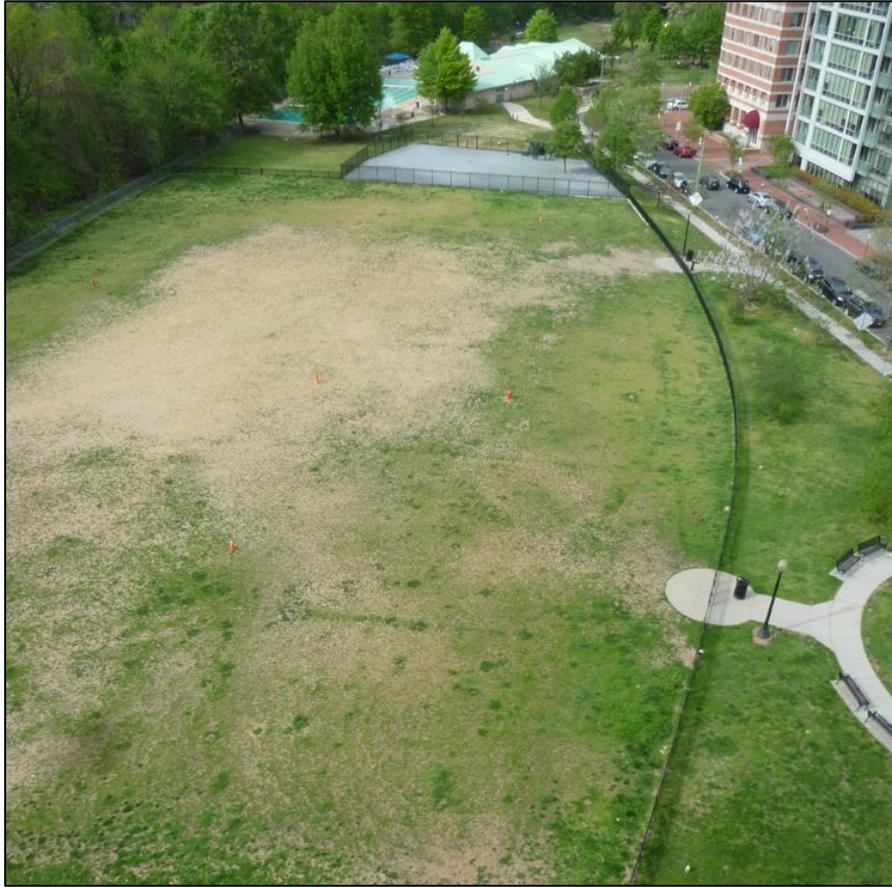
Figure 13. Francis Field condition in April 25, 2016 before experimental greening program.

In 2017, our organization, working with Advisory Neighborhood Commission 2A, and in partnership with DPR and the National Park Service (NPS), began an effort to improve the passive space by planting additional trees, and growing grass on the playing field, using private funding to restore the natural turf.

NPS set the specifications for the work on its portion of the field, which were adopted for the whole project. No herbicides were used, organic fertilizer was required, and the seed was a mixture of Kentucky Bluegrass and Tall Fescue.

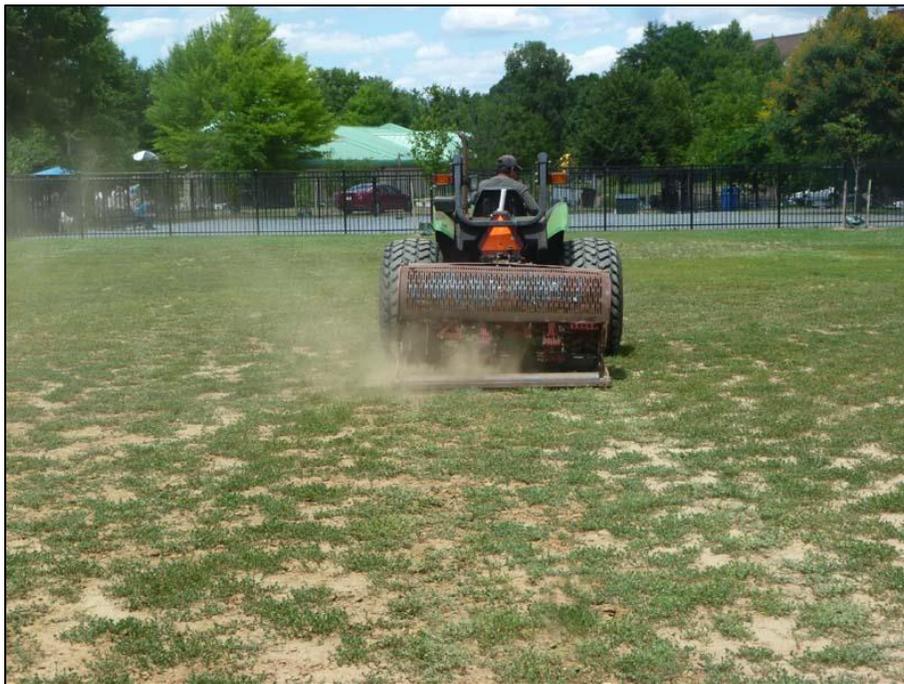
Figure 15. De-compacting playing field soil with tine aerator, June 2017.

The field was closed by DPR to permitting and play beginning June 19, 2017. De-compacting the field's hard-packed surface with a tine aerator was the first step. Summer was not the ideal time for planting grass, but the dates were set by DPR.

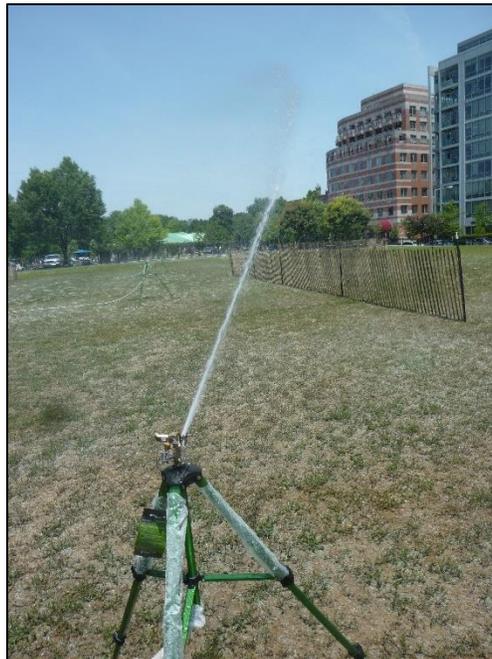
Figure 17. One of ten portable sprinklers for irrigation. Snow fence is shown in background.

Due to the limited water supply, irrigation for the new seed was provided by a temporary sprinkler system, run from one hose bib located on the swimming pool building, with each sprinkler on a battery-powered timer set so they operated one at a time.

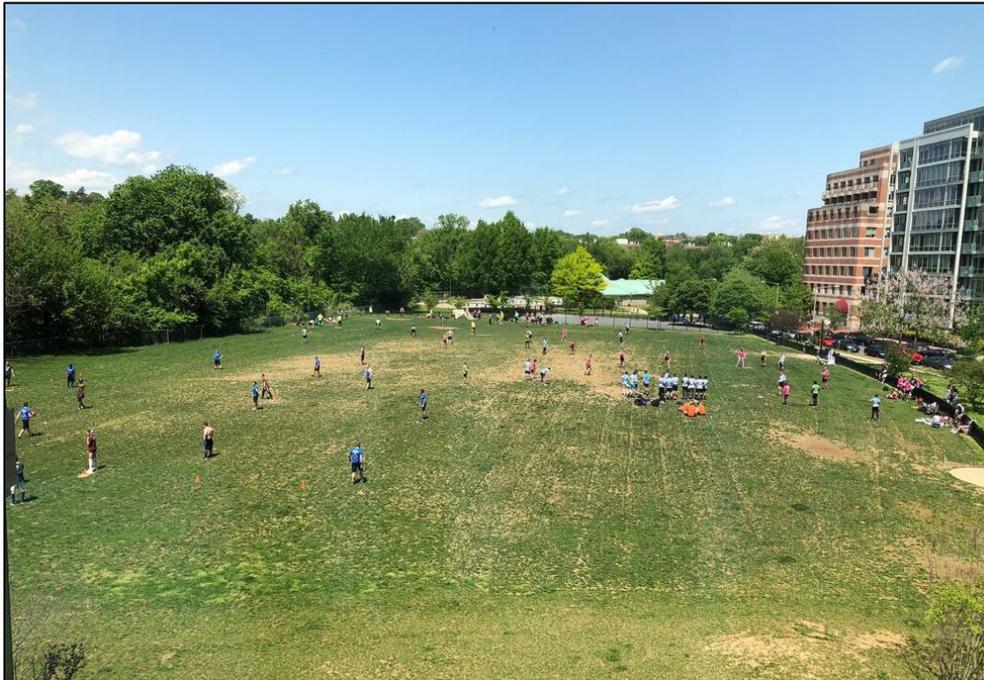
Figure 23. Kick-ball league and deteriorating field conditions, April 16, 2019.

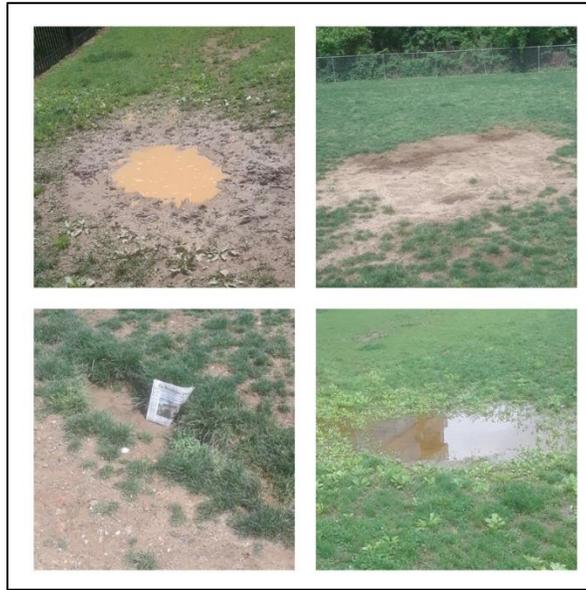
Figure 24. Holes, trench, and field damage, May 2019.

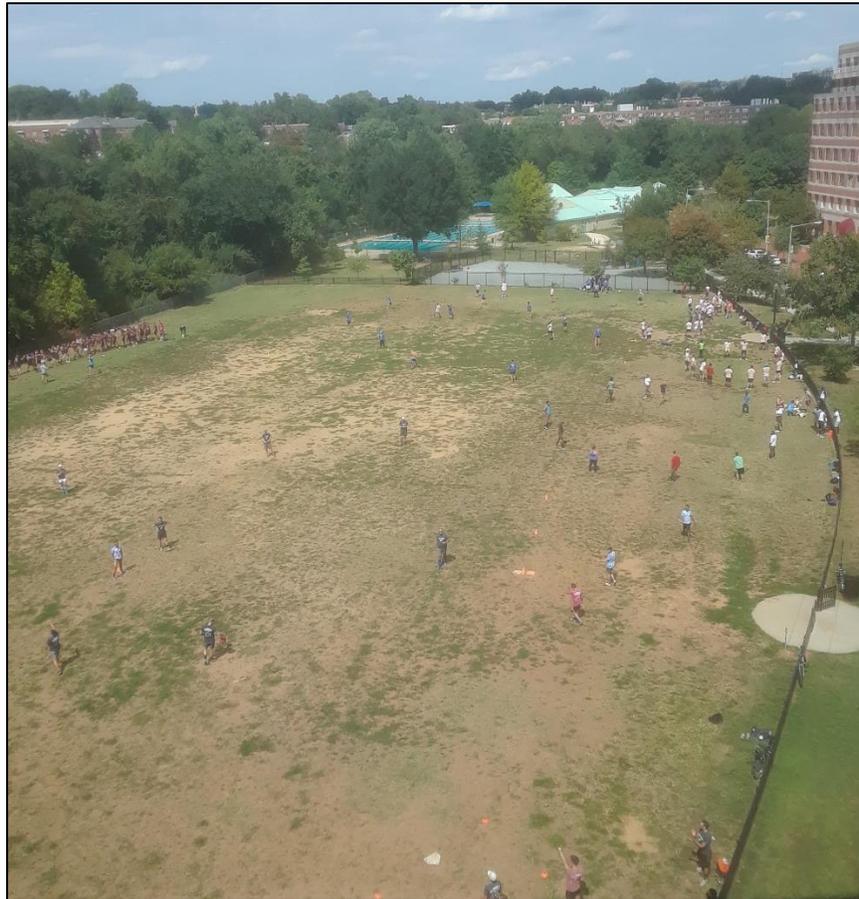
Figure 25. Field Condition, September 8, 2019.

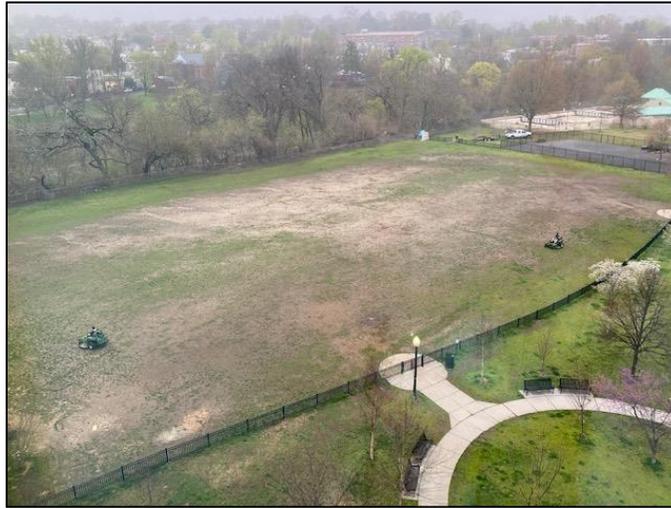
Figure 26. Field Condition, March 29, 2020, after field closed because of Covid-19 health emergency.

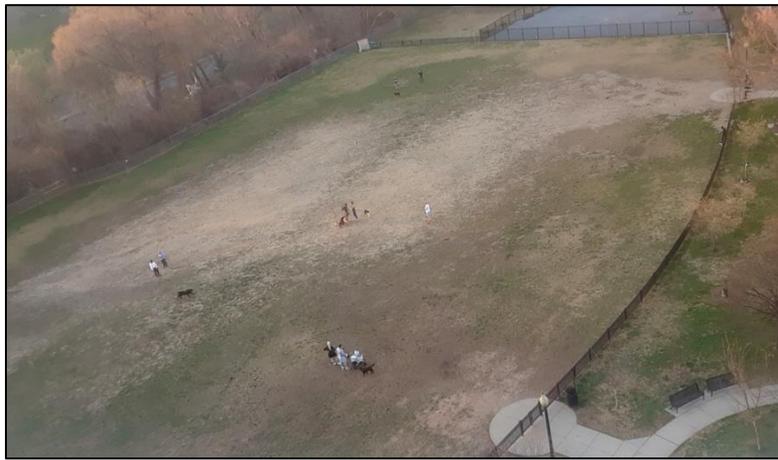
Figure 25. Field Condition, March 26, 2021.

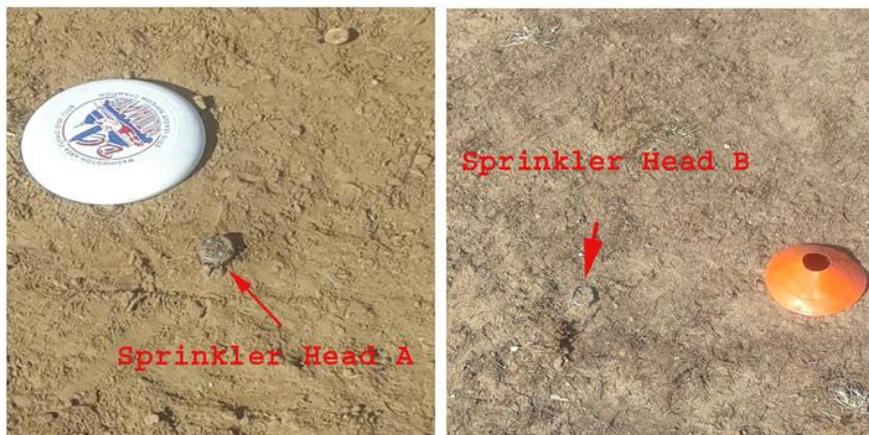
Figure 26. Sprinkler head tripping hazards, November 16, 2021.

The soil in several places is so worn down that sprinkler heads from the old irrigation system now protrude above the field surface, causing tripping hazards.

Recently, working with our Advisory Neighborhood Commission, we have requested DPR to prioritize making the field safe for school children. The former junior high school on the same block is now a K-through-8 school called the Francis-Stevens Education Campus.
